# 3751 ALMAGARD® VARI-PURPOSE LUBRICANT

MAJOR MINE OPERATION , Central Montana

Primary Crusher • SIC 1081 Metal Mining Services

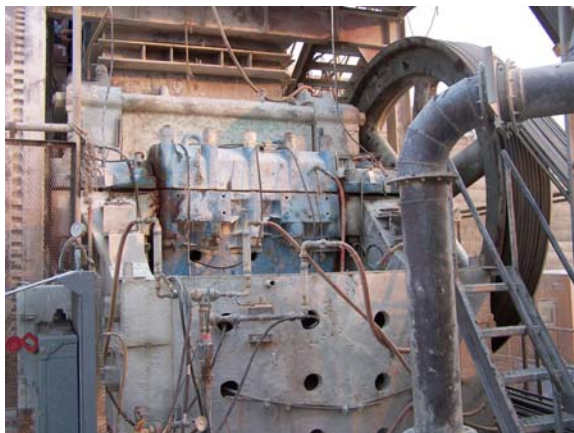
They operate a primary crusher. It is an older model jaw crusher that has Babbitt bearings. As you can see by the

Primary crusher bearing housing

pictures this is no ordinary jaw crusher; it is very large. There are 16 points of lubrication on the main bearing housing.

After spending a lot of time researching the problems with LE Technical Services Manager Steve Mauritz, and asking questions of several of his peers, a solution began to emerge. Multiple recommendations were made. The piping, lines and fittings all needed to be bigger to keep the grease from being restricted. A different type of lubricant and delivery system needed to be used as well. Early in Spring 2007, the mine began replacing all of its 1 inch pipe in favor of 2 inch 10k psi pipe. They eliminated all the 3000 psi hydraulic line for 5000 psi line. They changed all their fittings

to 3/8 from 1/4". The single farval system remained but plans to add another system is on their way. Last but not least LE 3751 ALMAGARD® Vari-Purpose Lubricant was installed via a steel tote. A Liquidynamics air operated grease pump specifically designed for totes was installed (mdl 11396 as shown in picture).

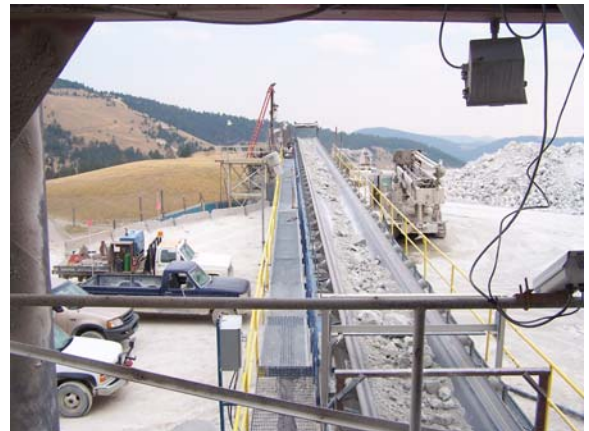
Conveyor

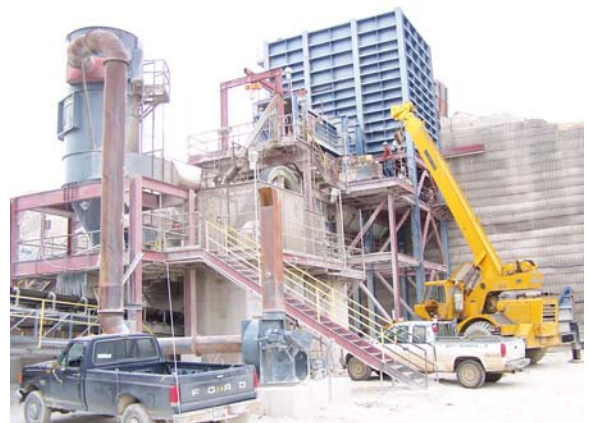
Primary crusher structure

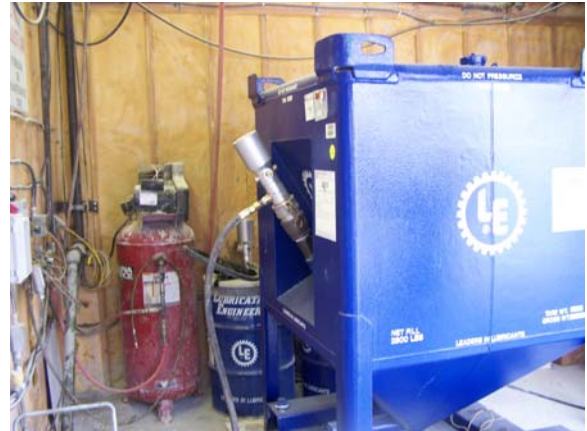
Grease tote setup
